**MARYLAND HISTORICAL TRUST
DETERMINATION OF ELIGIBILITY FORM**

Dairy House, Spring Grove

State Historic Sites Inventory Form

historic Dairy House

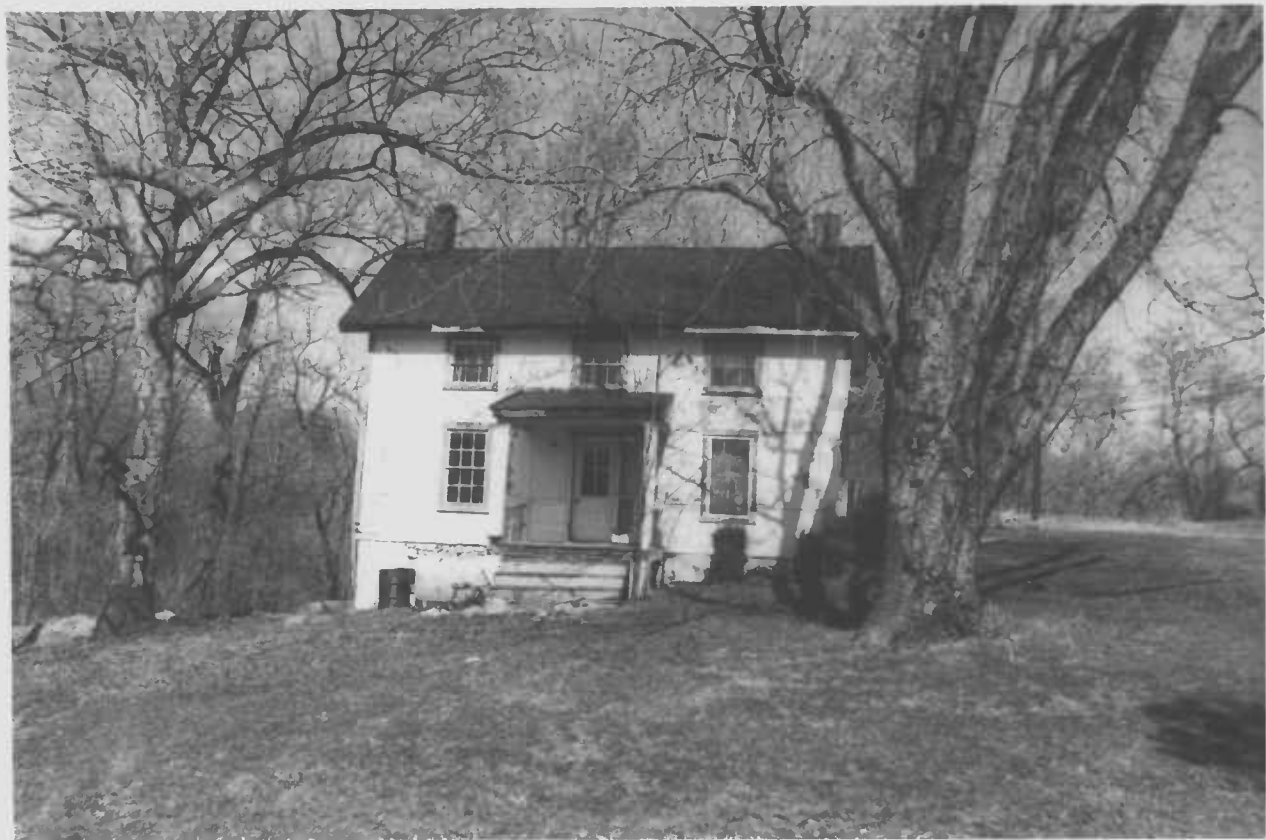
WEST WALL

A simple portico characterizes the western facade. Supported by brick piers, the wooden portico has tongue and groove flooring and square turnposts. The balustrade no longer exists, and in some places has been replaced by a chain-link fence. The portico frames the main door. Though the door is original because of its porcelain doorknob and Victorian hardware, the rest of the door treatment remains undistinguished. Two windows flank the central doorway. Flat pieces of wood form a square surround and lintel around these 6/6 double-hung sash windows. The three second-floor windows show a slight variation: a 3/3 sash and a triangular shaped lintel. The west facade reveals an unusual treatment on the first story. Attached to the stucco, clapboard siding appears from the stone foundation up to the first floor window sills like an exterior wainscoting.

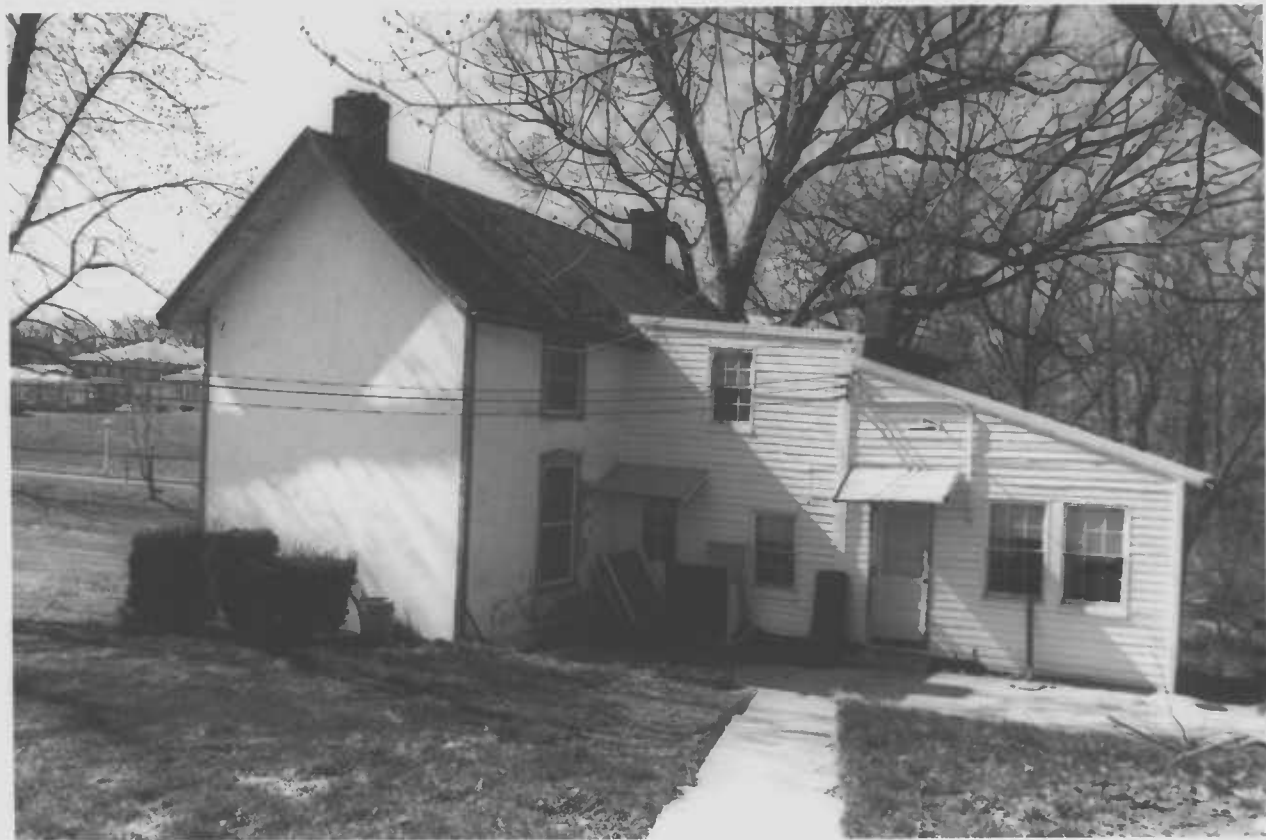
SOUTH WALL

The gabled ends on the north and south are enclosed by wooden framing members. The southern wall is detailed only by the plain, projecting verges. While the northern wall displays the same verges, it also shows a first and second floor window. Though deeply recessed, the windows demonstrate the same lintel treatment of a flat, wooden triangular pediment. These casement windows appear on the eastern portion of the northern wall, close to the clapboard addition. The triangular lintel is repeated on the eastern wall as the windows match the treatment of the western facade: first floor-6/6 sash, second floor-3/3 sash.
